# VILLA ORSI

2016 - 2017  
Project and works for renovation  
A story through images

© 2018 Lucchini Architetti – Cannero Riviera  
Matteo Lucchini, Guido Lucchini  
Collaborators: arch. Stela Mullisi, arch. Anna Proskuriakova

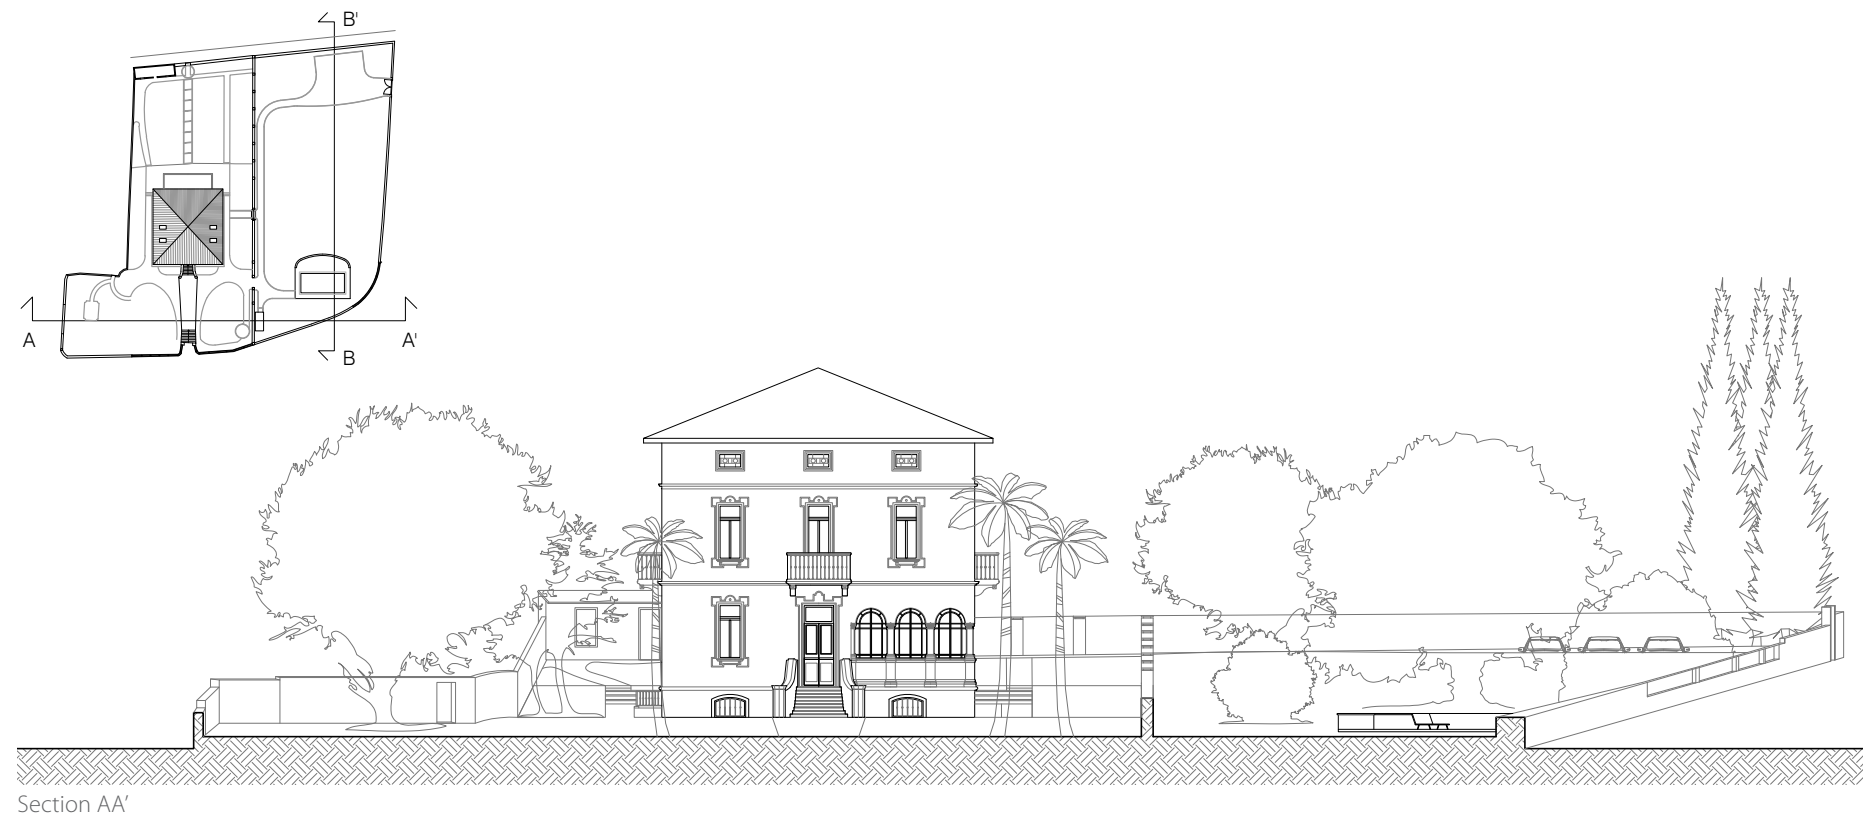
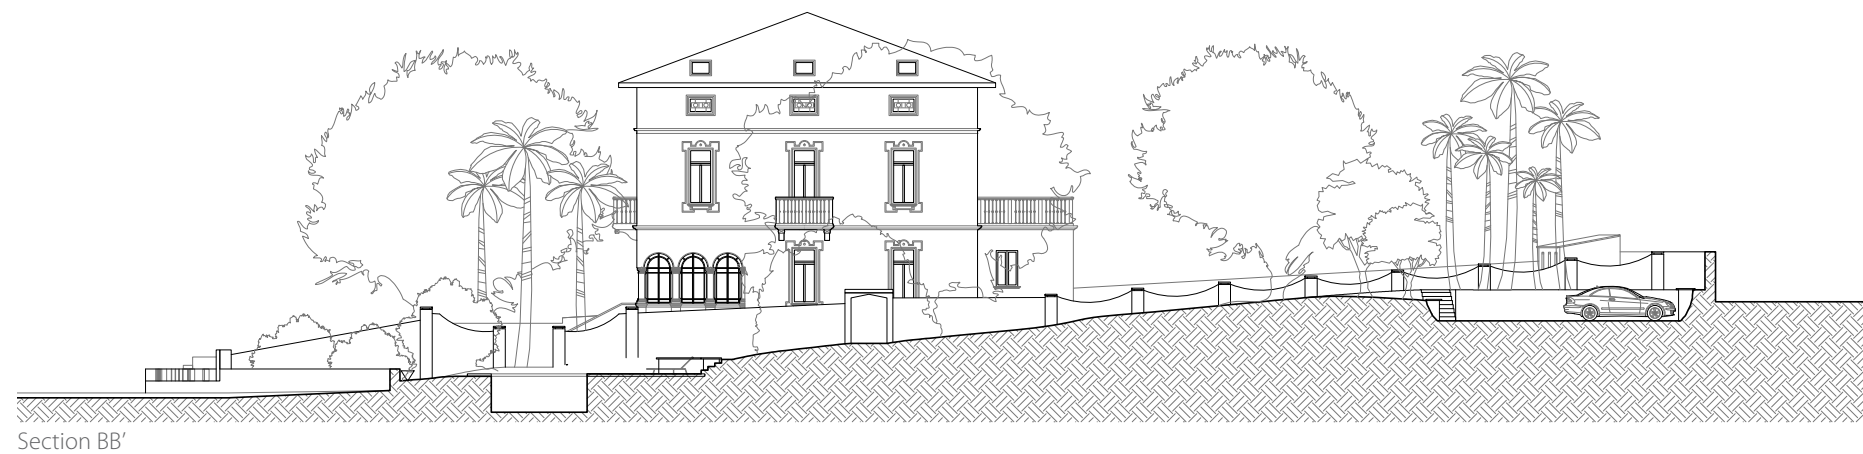
Section BB'

Section DD'

The main redevelopment intervention on the ground floor was that of giving back to the northern facade its original composition, characterized by the harmonious and simmentric design of the terrace and the portico, closed by two masonry shoulders and supported by concrete columns (see photos on the following pages). Therefore, were carried out the demolition of the rooms used as kit-

chen since the late 70es, and the reopening of the portico, using white granite columns of Montorfano to replace the concrete columns. The small toilet in the basement has been demolished, and a new small bathroom has been created in correspondence of the narrow accessory compartment of the old kitchen. The slab of the terrace above was very damaged in 2016, and needed a redevelopment and waterproofing. The ceramic flooring, of modest quality, was seriously damaged, the same was for the concrete balustrade and metal pillars. The new kitchen was created in the room that at the time of the beginning work was used as a bookcase / study, in direct connection with the dining room, through a door inserted in a new elegant wardrobe accessible from both sides, The interventions on this floor, were completed by the maintenance and recovery – where necessary -, of the internal floors, in “Seminato Veneziano” and in parquet.
